INTERIM REPORT

FEBRUARY 1988

EVT 5-88

ENGINEERING TEST OF THE M2A2 PALLET ADAPTER AND TOP LIFT FRAME

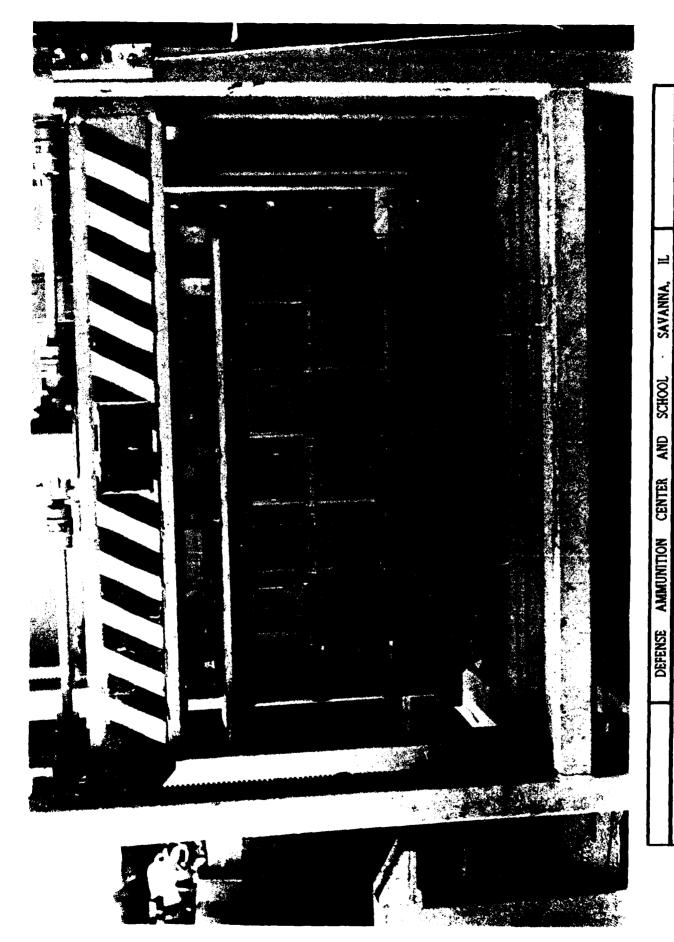
The test pallet was loaded to 13,500 pounds compression for a period of one hour. At the end of the one hour period, the compression load had decreased to 11,300 pounds, but no measurable compression was noted in the load.

Photograph No. 1. Test pallet in the Compression Tester.

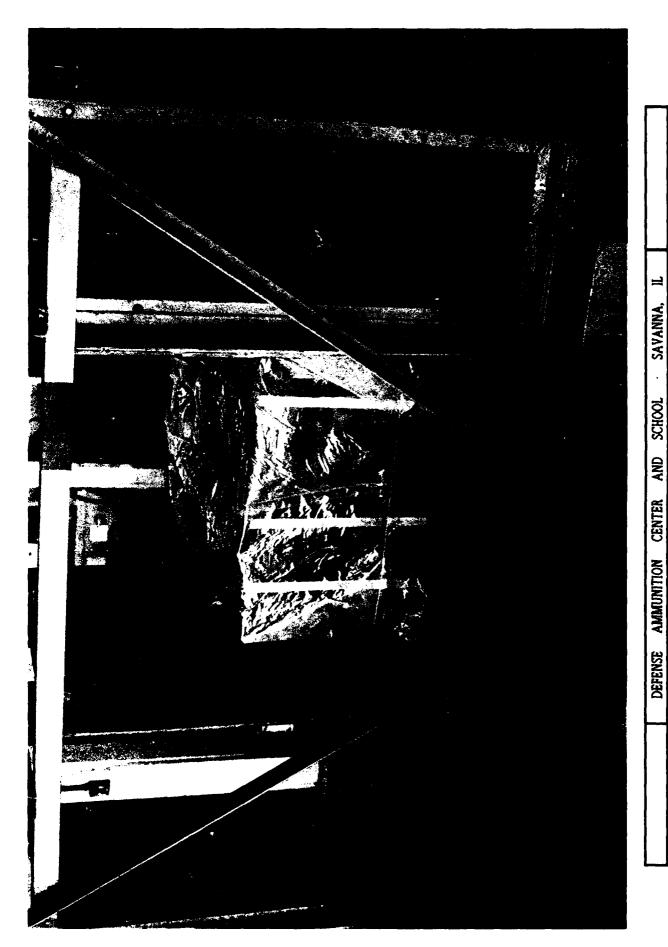
The test pallet successfully passed both the longitudinal and lateral transportation simulation. Duration of the test was 90 minutes for each orientation of the pallet. In order to achieve the required 1/16-inch clearance between the pallet and the Transportation Simulator bed, the equipment was operated at 235 rpm for the longitudinal orientation and 215 rpm for the lateral orientation. At the completion of the test, it was noted that three of the hinge pins on the plastic M2A2 cans had vibrated out several inches. (See Photos)

Test pallet in the Transportation Simulator in Lateral Orientation. Photograph No. 2

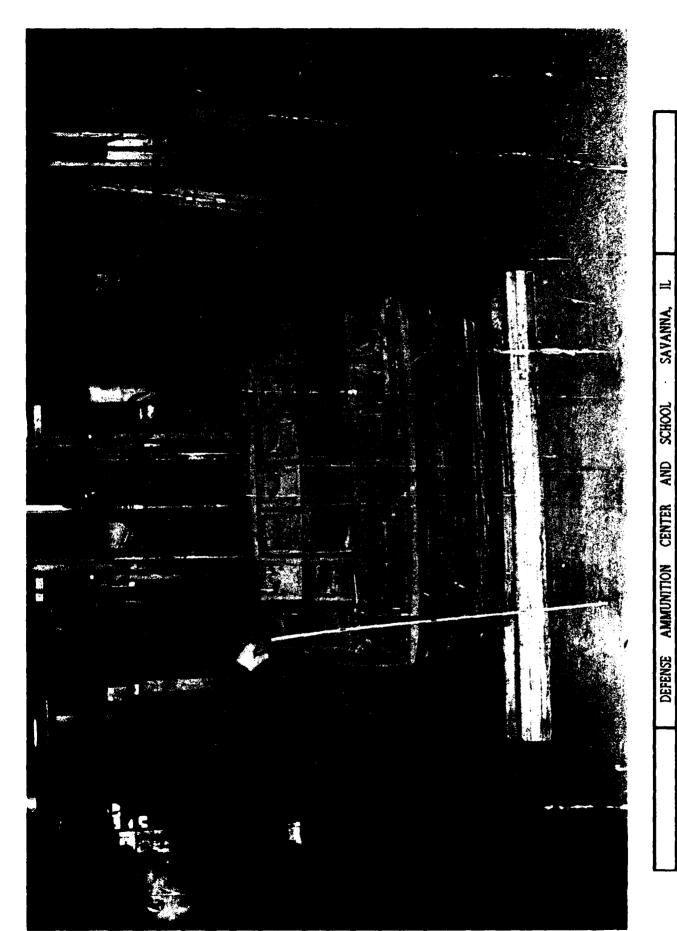
drops, no damage was sustained by the pallet adapter or load, but the outer edge of the skid opposite the displacing beam was bent. On the second and fourth drops, the pallet and pallet adapter were bent along the length of the skids. The bending of the pallet created a gap between the top lift and the center set of containers.

Photograph No. 6. Test pallet being raised 24 inches prior to the third edgewise rotational drop test.

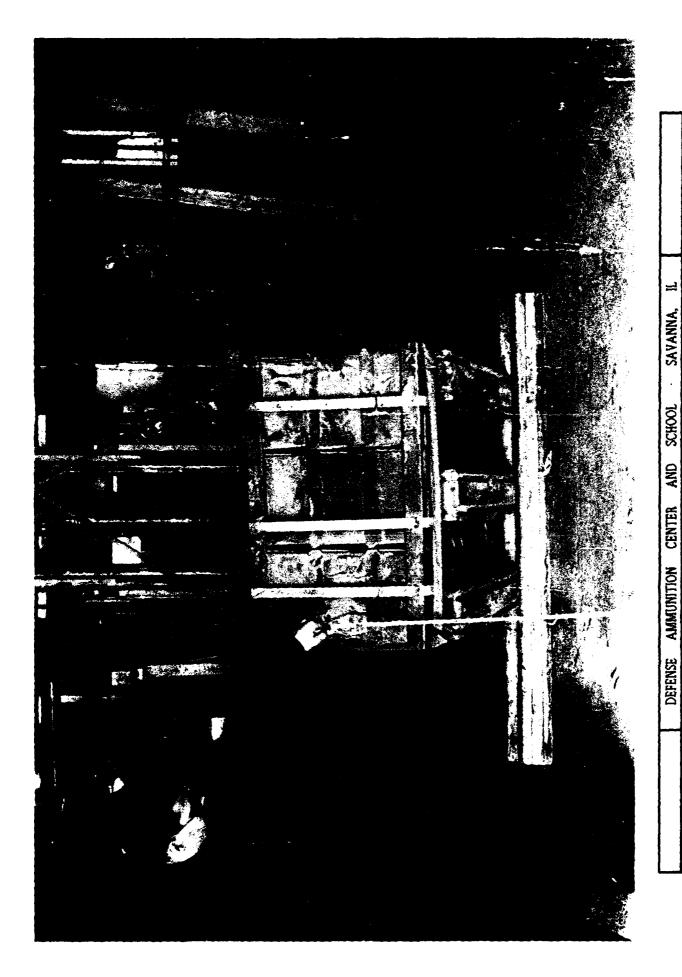
Test pallet being raised 24 inches prior to the fourth edgewise Photograph No. 7. rotational drop test.

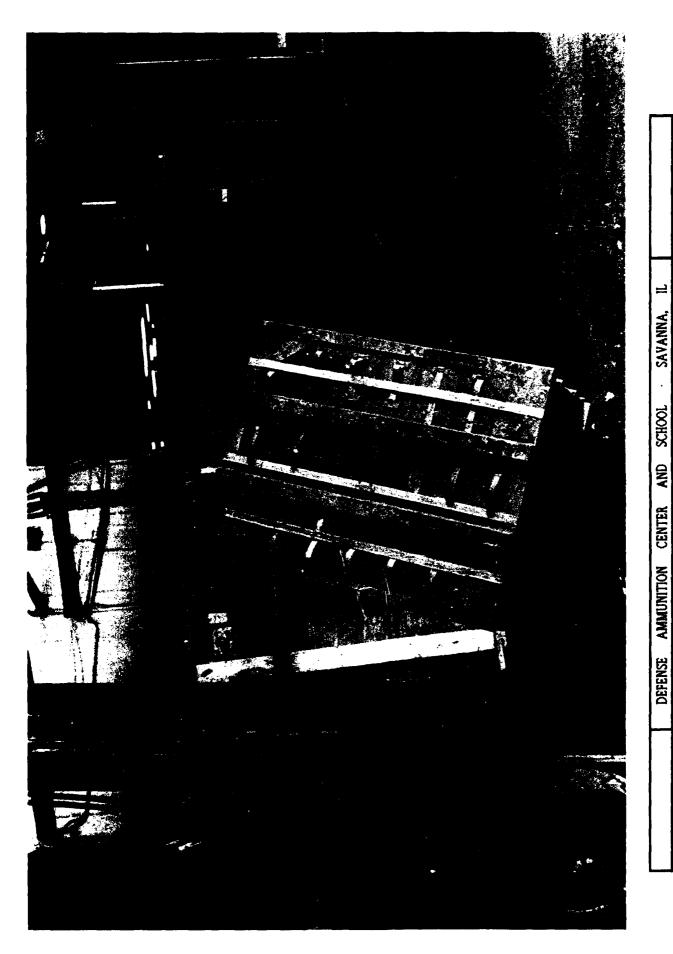
The sling test consisted of five different lifting configurations using a top lift adapter and a four legged sling. The configurations used for this test consisted of a four corner, three corner, two alternate corners, two adjacent corners, and a single corner lift. No damage was sustained by the pallet or the top lift adapter from the sling test.

Photograph No. 12 Test pallet being lifted by one point with a sling.

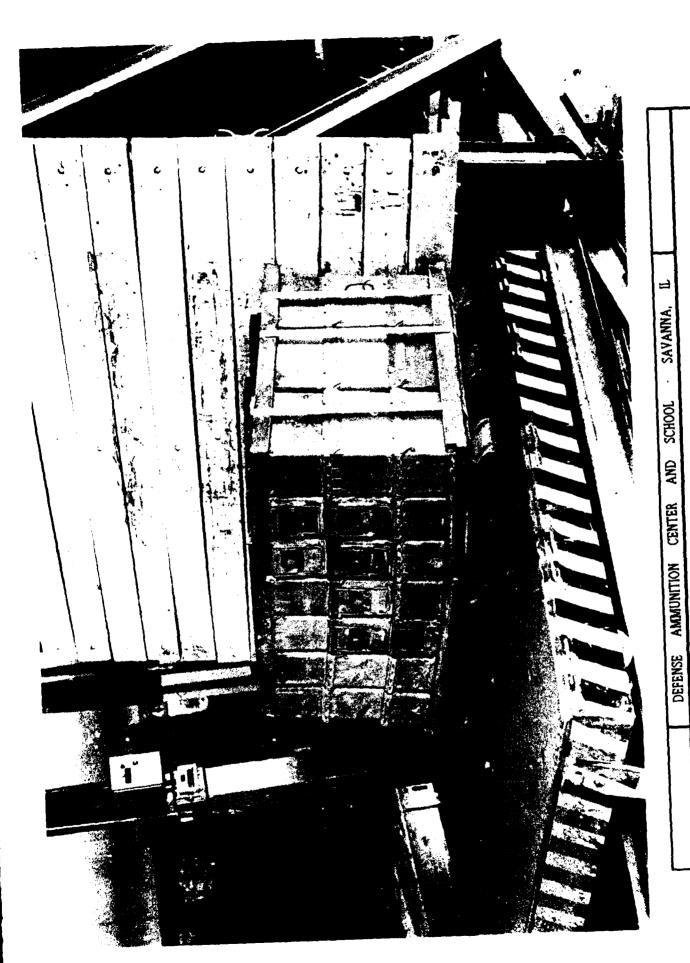
The incline impact tester was set to allow the pallet to travel 8 feet before impacting the bumper of the impact tester. In between impacts, the pallet was rotated in a clockwise direction until all four sides of the pallet had been impacted. During the first impact, the outer edges of the top lift frame that are perpendicular to the impacting surface were bent outward. On the second and fourth impacts, the containers compressed together towards the impact wall leaving a large gap between the bands and the end containers. Also, the second and fourth impacts caused several of the center cans to rack up and out of position. Finally, the third impact caused no additional damage to the pallet.

Photograph No. 13. Test pallet prior to impact one of the inclined impact test.

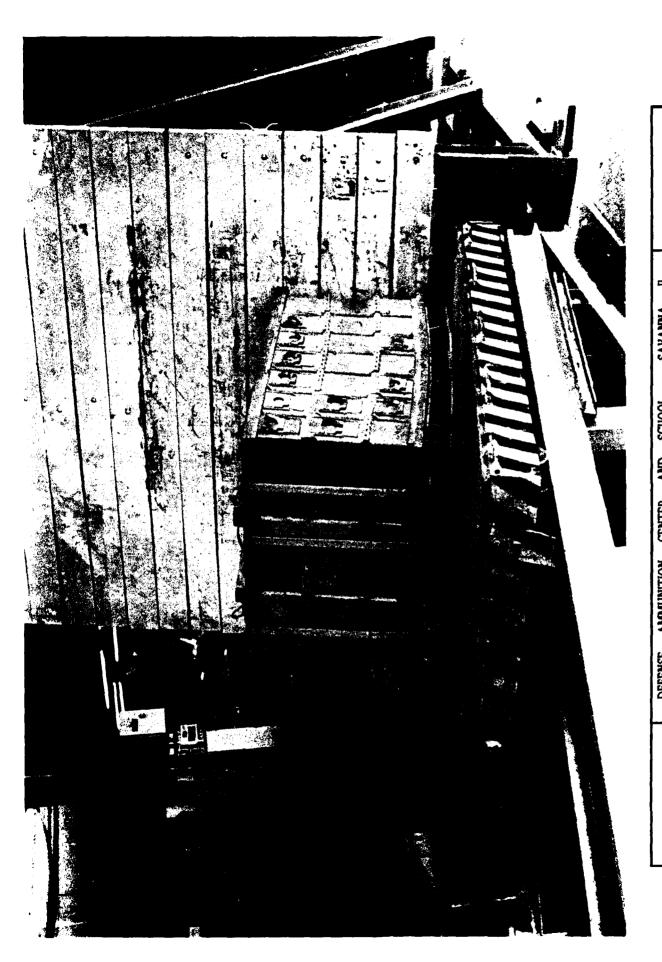
Test pallet prior to impact two of the inclined impact test. DEFENSE AMMUNITION CENTER AND SCHOOL - SAVANNA, Photograph No. 14.

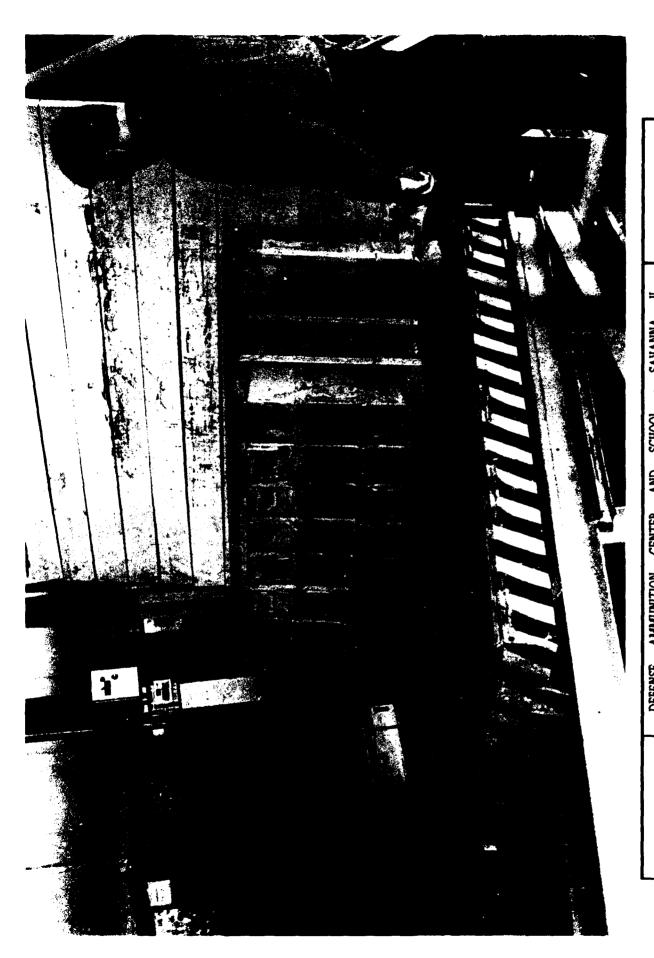
Test pallet prior to impact three of the inclined impact test. Photograph No. 15.

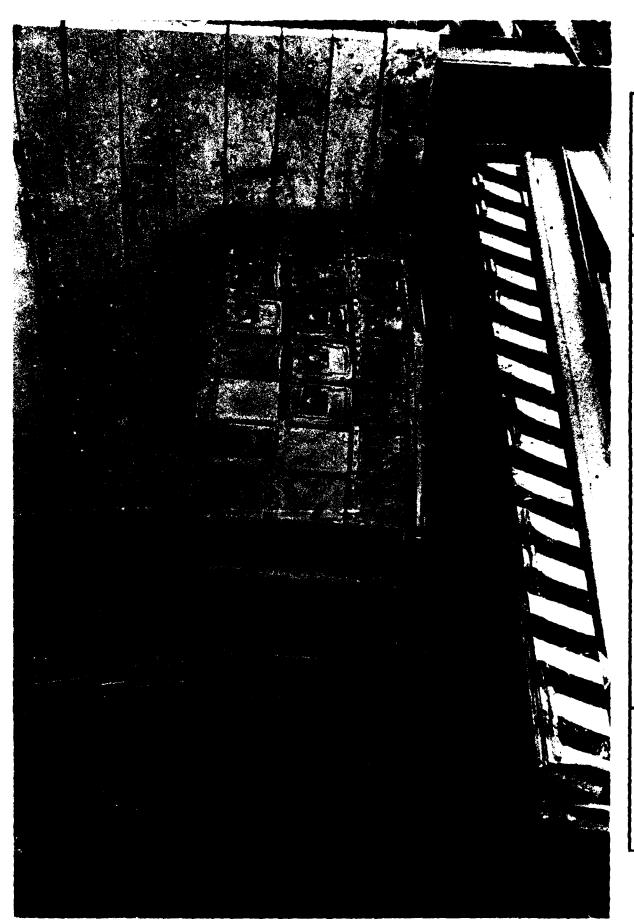
Photograph No. 16. Test pallet prior to impact four of the inclined impact test.

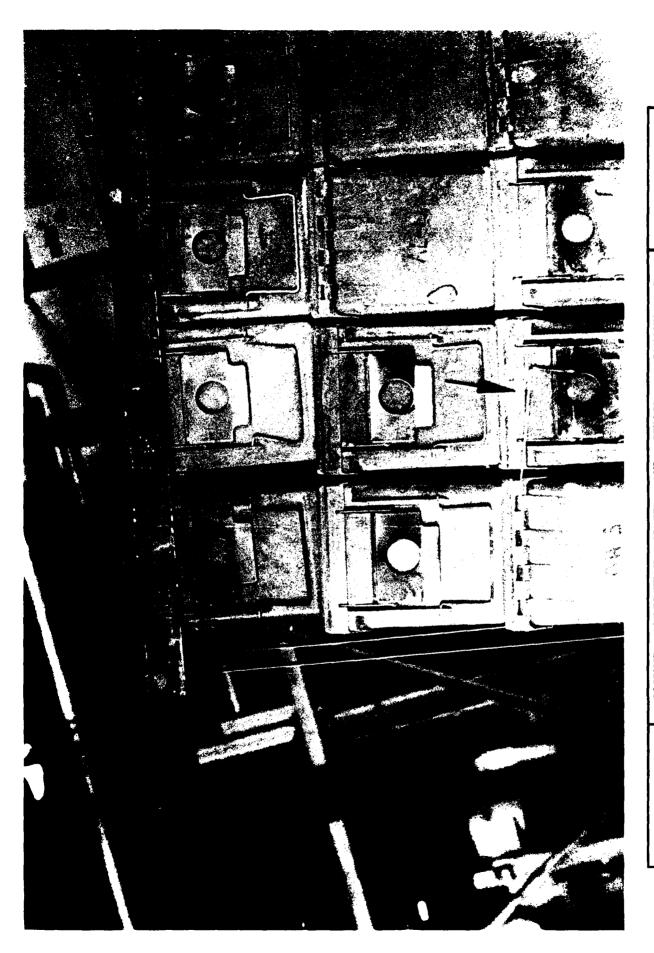
This photograph shows one of three hinge pins that worked out Photograph No. 17. during the test.

- 2. <u>RECOMMENDATIONS</u>. Since the performance of the test pallet was marginal, it is recommended that further testing be performed to verify the suitability of the pallet adapter and top lift frame for transportation of plastic M2A2 containers. The pallet adapter and top lift frame should be redesigned prior to additional testing to eliminate the bending that occurred during the edgewise drop test and inclined impact. The redesign should include provisions for strengthening of the pallet adapter and top lift frame and also a reduction in the size of the pallet adapter and top lift frame to reduce the racking of the containers.
